WL-TR-91-4032
DOT/FAA/CT-91/23
VOL II, Part 3

COMPOSITE FAILURE ANALYSIS HANDBOOK
VOLUME II - TECHNICAL HANDBOOK
PART 3 - CASE HISTORIES

R.J. Kar
Northrop Corporation
One Northrop Avenue
Hawthorne, California 90250-3277

February 1992

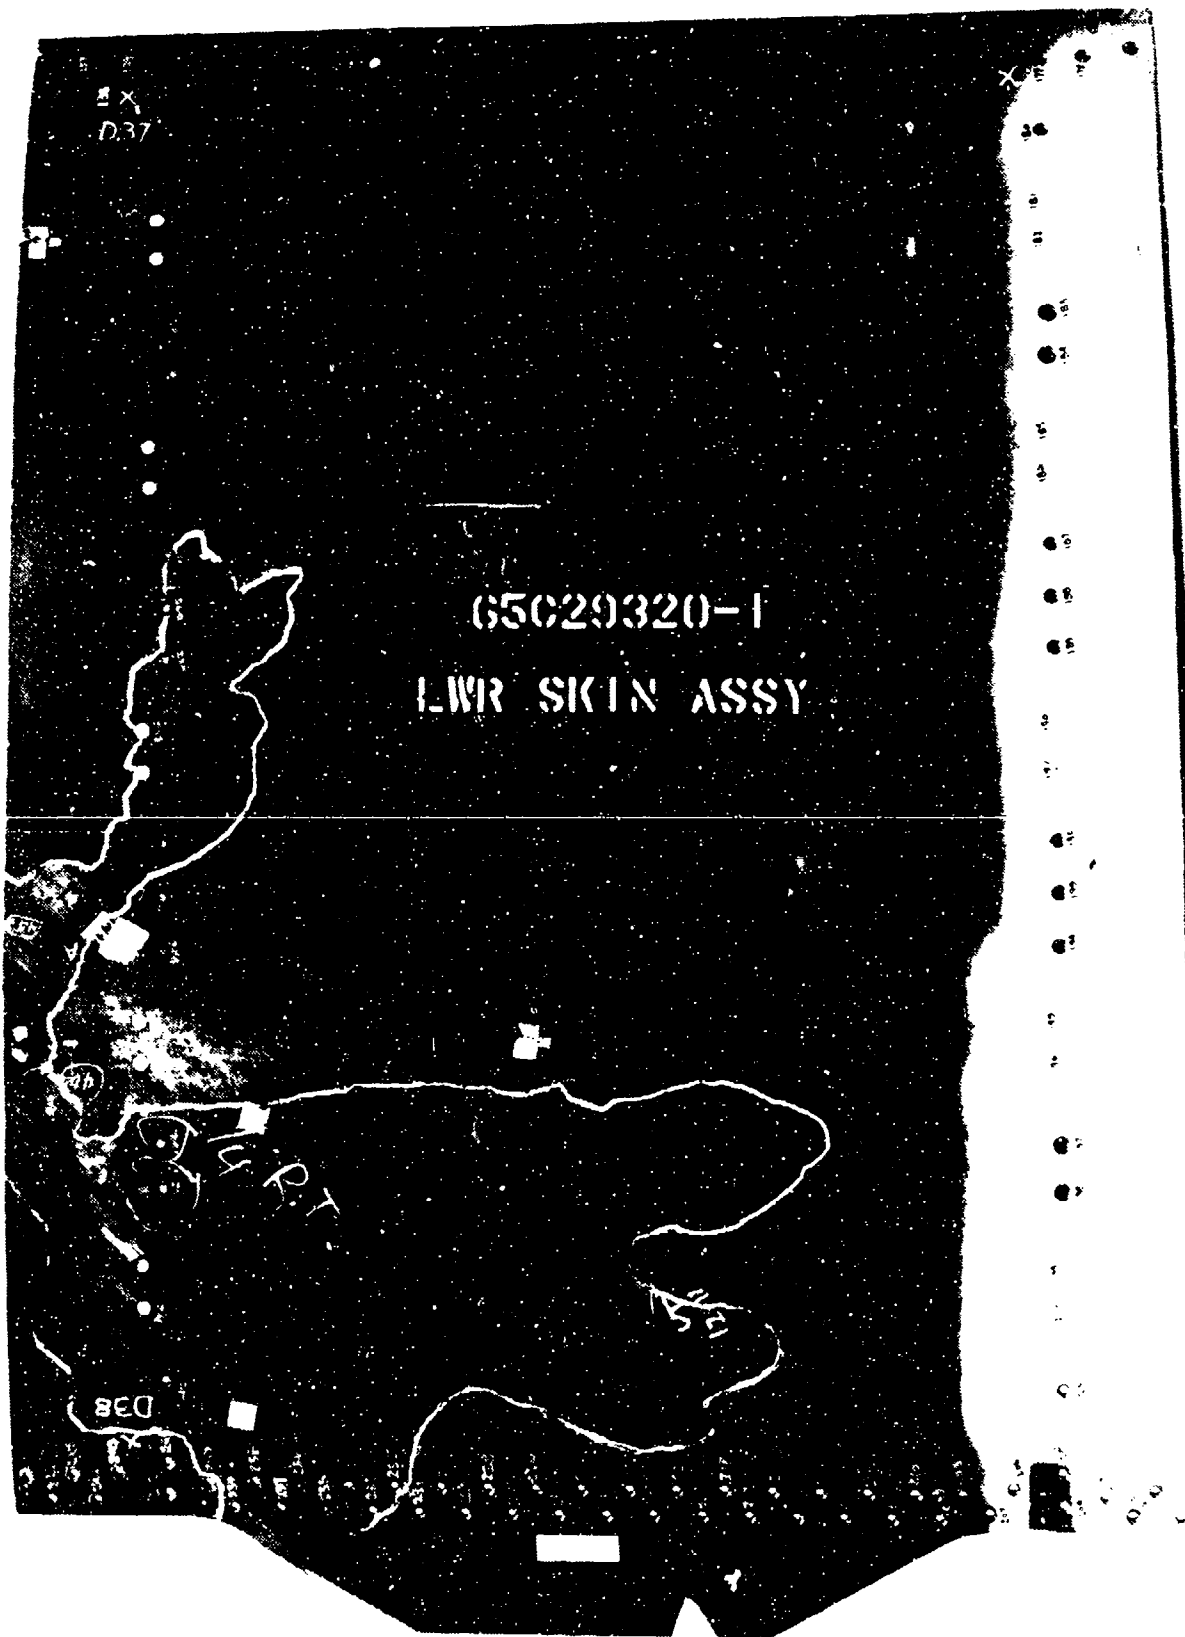
Figure 2-6. J4X Wing Test Box Lower Skin Surface

The lower skin surface, shown in Figure 2-6, was damaged in a similar manner to the upper skin, although to a lesser extent. The skin buckling also indicated a compressive loading. Since the stress prior to fracture was supposed to be tensile, the neutral axis between tension and compression must have shifted to below the lower skin surface during the failure process. As a result of these visual observations, it appeared that damage in the upper skin and spars occurred prior to cracking in the lower skin.

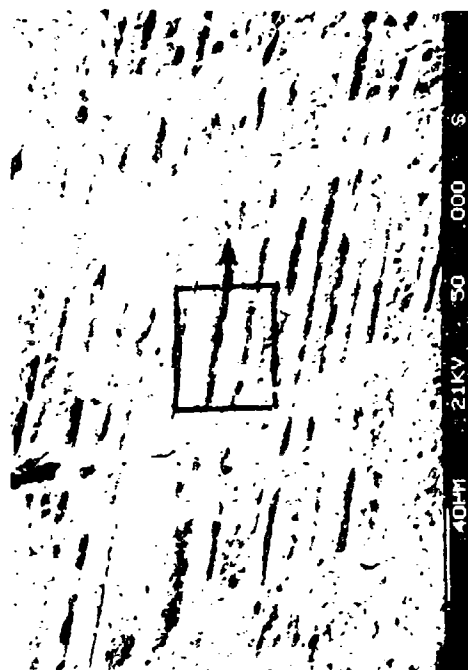
SEM examination was performed on the single delamination of the small piece. Evidence of shear fracture (scallop and hackles) was observed on the laboratory-exposed surface of this delamination (see Figures 2-46 and 2-47). The propagation direction was oriented axially along the length of the strut, but the exact direction could not be determined. Examination of the tensile half of the translaminar fracture revealed radial patterns on fiber end fractures (see Figure 2-48). The resultant direction of crack-propagation, determined by mapping the directions in which the lines radiate in the individual fiber fractures, was from the lower surface (tension) toward the delamination. Examination of the compressive half of the translaminar fracture revealed buckled fibers displaying chop marks (see Figure 2-49), typical of compressive failures. Although SEM examination of the translaminar fracture was conducted around the bolthole region, the non-conducting surfaces encountered produced images which were not of sufficient quality to include in this report. SEM examination of the translaminar fracture was difficult to perform, due to the extreme depth of this fracture. This prevented adequate application of gold (even after multiple sputter applications) to get a uniformly covered surface. Therefore, charging of uncoated areas during SEM examination made the location of suitably informative, fiber fractures difficult to perform.

Figure 2-46. SEM Fractographs of Delamination at the Translaminar Fracture Surface of the Small Piece
Scallops indicate shear fracture. The orientation of these scallops indicates propagation of the delamination axially along the strut.

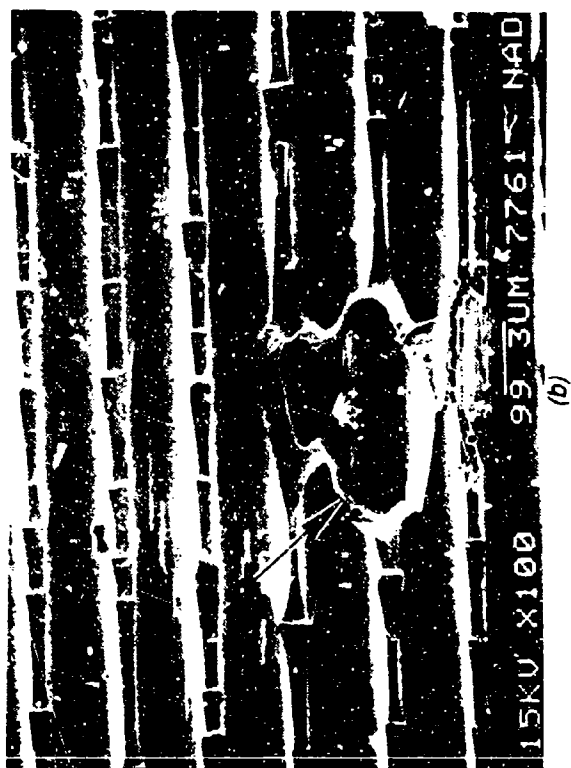
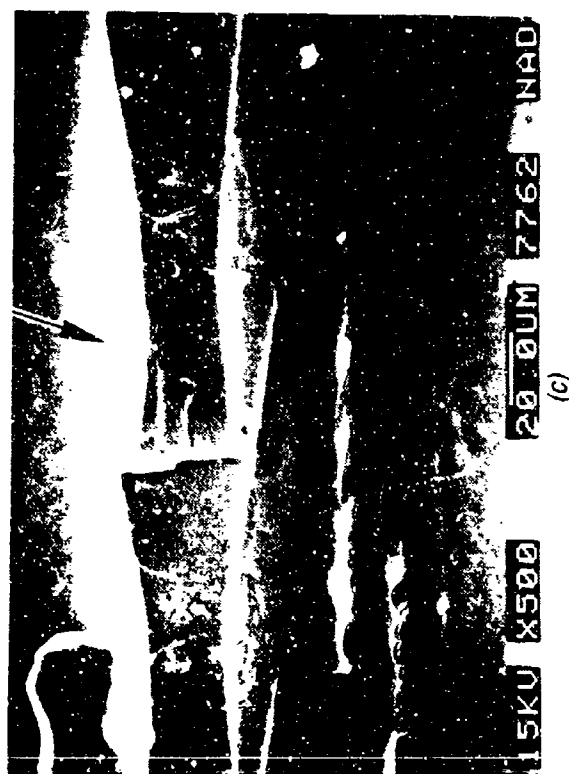
Figures 2-56 and 2-57 show SEM photographs of fracture features observed in the delamination region and in regions adjacent to the delamination. In the region of the delamination, the fracture surface exhibited a "resin-starved" condition, with very little evidence of fracture. As shown in Figure 2-56, stray hackles could be observed; however these were associated with very fine porosity. The epoxy ridge shown in Figure 2-55 was also associated with fine porosity (see Figure 2-57b). The laboratory fracture regions, in contrast, were associated with peel fracture characteristics in the form of river patterns in fractured epoxy (Figure 2-57c).

Figure 2-56. SEM Photographs of Delaminated Surface
 (a) Low Magnification
 (b) Intermediate Magnification Showing
 Resin-Starved Condition (Arrow)
 (c) High Magnification Showing Porosity (Arrow)

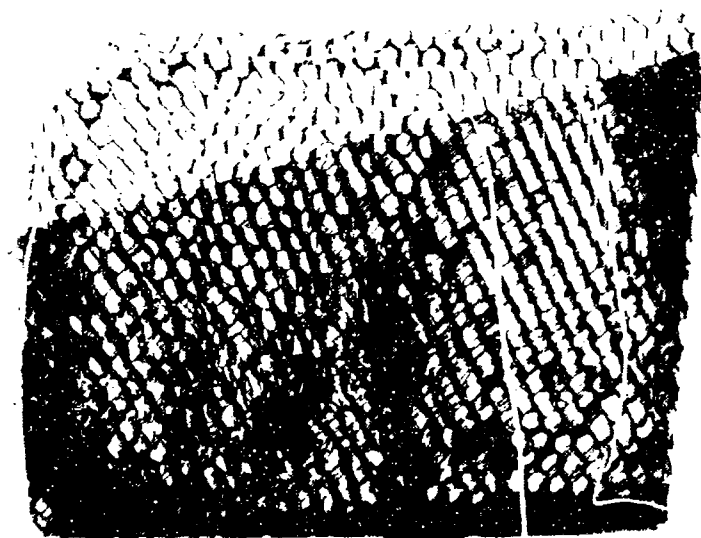
The occurrence of porosity in the defect was considered unusual and suggested that it may have occurred prior to the delamination event. Consequently, X-ray examination was carried out on the rudder assembly. Radiographic examination revealed a "blown-core" condition in the rudder as is illustrated in Figure 2-58.

The occurrence of a blown core condition indicated that moisture had played a role in the failure event. It was concluded that failure occurred when repair was attempted with wet core. During repair, the moisture turned into steam, and caused localized delaminations in the outboard skin.

Figure 2-58. X-Ray Radiograph Shows Blown-Core in Rudder

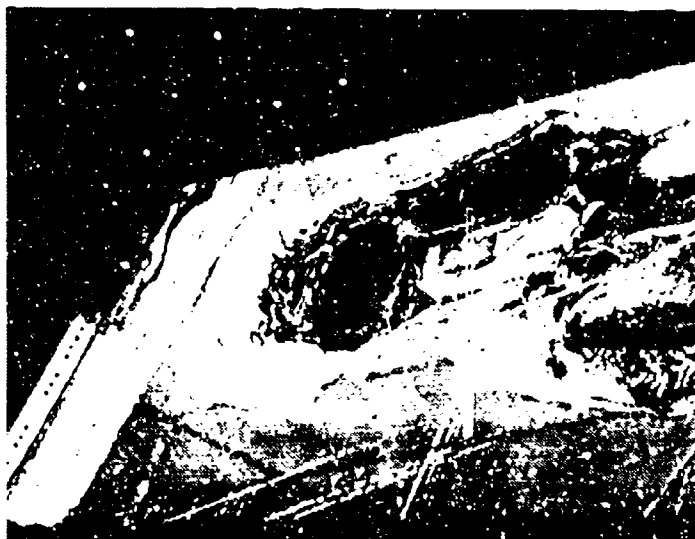
Detailed 2-D and 3-D pulse echo ultrasonic imaging was concentrated on these two zones of damage. Figure 2-63 shows pulse-echo images of the damage at the outboard end. Orthogonal cross-sections of the 2-D image (Figure 2-63a) revealed that the damage in this zone (hereafter referred to as zone A) consisted of two principal regions of delamination (Figure 2-63b) with one close to the outer skin, and the second closer to the back face of the skin. Damage in the mid-section location (hereafter referred to as zone B) started at or very close to the top face, and extended across the flight surface and into the interior (Figure 2-64).

Figure 2-64 Pulse-Echo Images of Damage at the Mid-Section of the Stabilizer (Zone B)
(a) 2-D Image
(b) 3-D Image

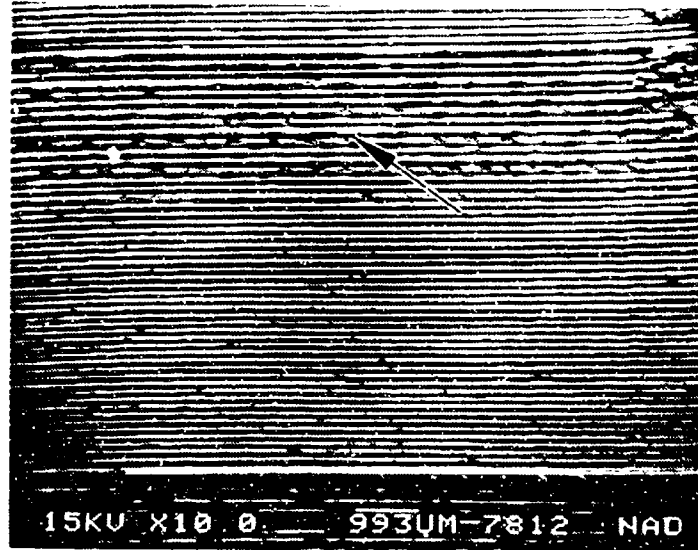
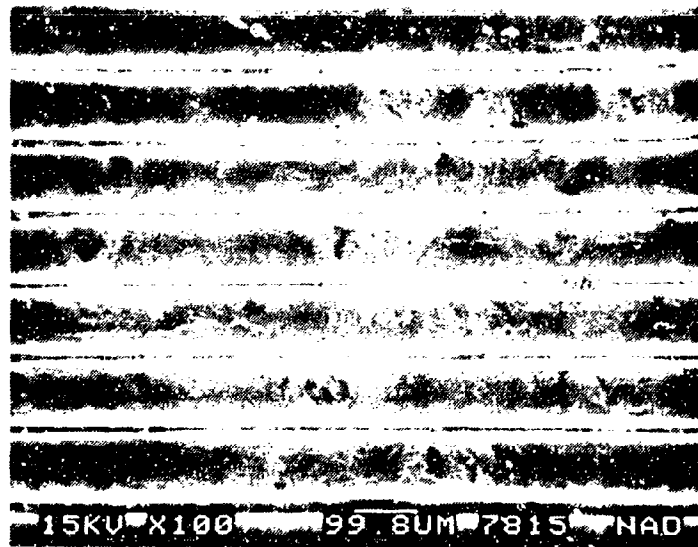
Figure 2-67. SEM Photographs of Delamination in Zone A (Second Layer Removed)
 (a) Central Region of Resin Starved Fibers (Arrow)
 (b) High Magnification Photograph Showing Detail in Central Region

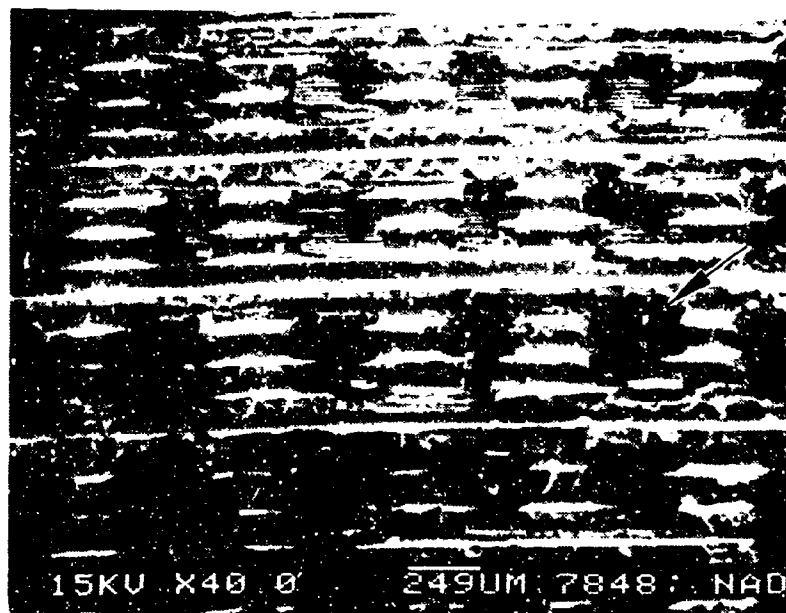
Figure 2-69 shows SEM photographs of the delaminated layer in zone B. Again mapping of the rivers indicated local fracture propagating by peel radially across the surface with key-holing (Figure 2-69a) and an abundance of compression debris.

Figure 2-69. SEM Photographs of Zone B Delamination (Top Layer Removed)
 (a) Low Magnification Showing Key-Holing (Arrow)
 (b) High Magnification Showing Compression Debris (Arrow)

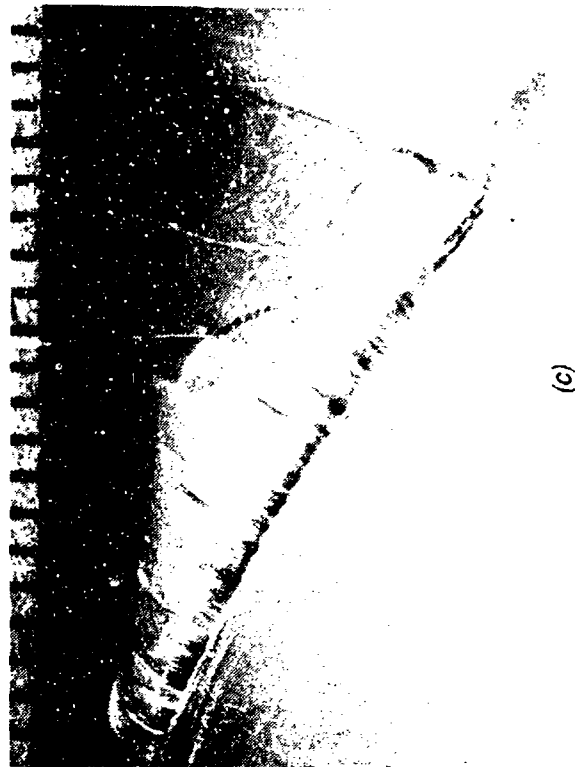
Figure 2-70a shows the component in the as-received condition. Visual examination of the component revealed that the part was filament wound and that it exhibited a surface condition in the form of a diagonal bulge (shown in Figures 2-70b and 2-70c) present around the outer periphery of the gage section of the cylinder.

Conventional ultrasonic testing of the component was unsuccessful because of the non-availability of a transducer with a cylindrical contour. X-ray radiography was carried out and revealed indications in the area of the bulge previously detected by visual examination. No other areas of damage were detected in the hollow cylinder.

Figure 2-70. As-Received Documentation of Failed Cylindrical Specimen
 (a) Overall Specimen
 (b), (c) Surface Bulge on Periphery of Cylinder

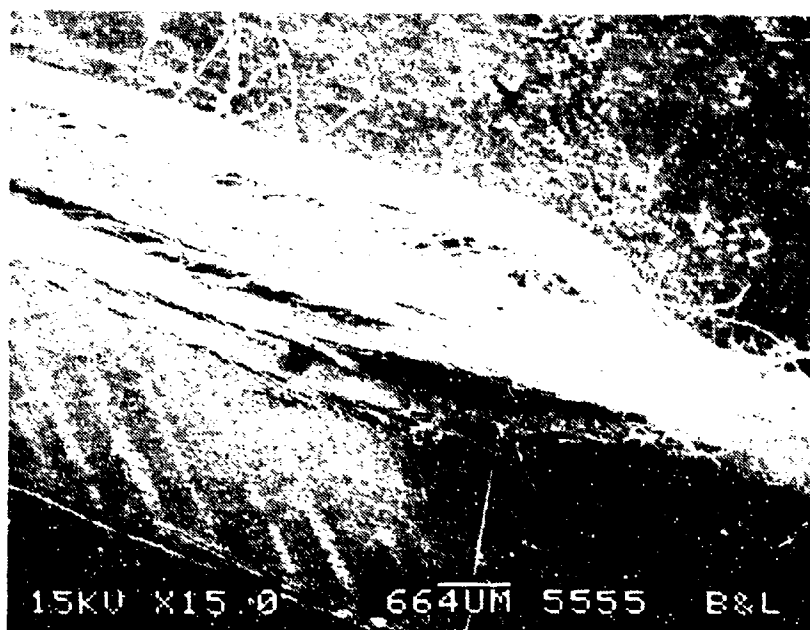
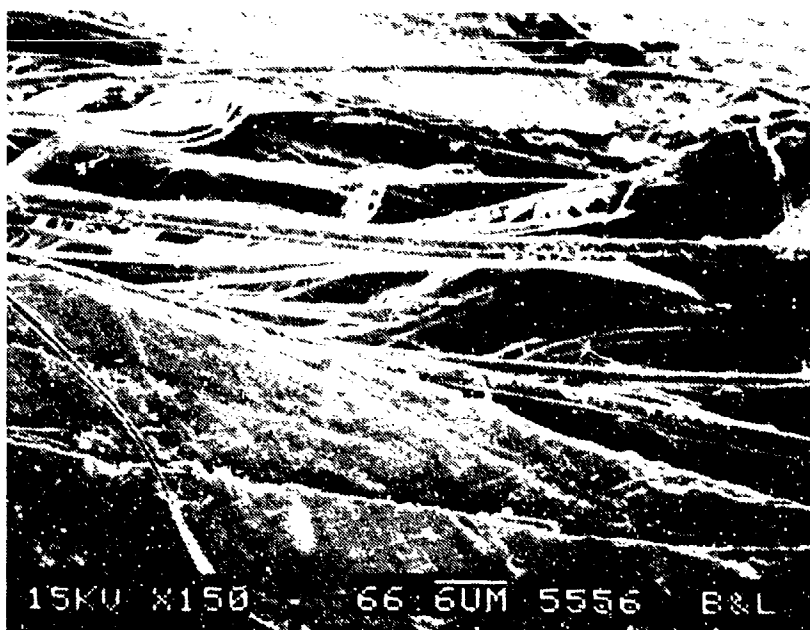
SEM examination was carried out on the outer and inner surfaces of the cylinder. Figures 2-73, 2-74, and 2-75 present SEM photographs of fracture present on the outer and inner surfaces. As shown in Figure 2-73a, the region of damage on the outer surface consisted of localized displacement of fiber bundles, splitting of fibers, and defibrillation of fiber ends. Figure 2-74 presents SEM photographs of the outer surface with the cluster of fibrils removed. As can be seen in Figure 2-74a, the fractured resin exhibited hackles, and the fibers appeared to be bending under shear loads (Figure 2-74b). Such fracture characteristics are typical of failure due to localized in-plane shear stresses caused by torsional loads. Figure 2-75 presents SEM photographs of the inner surface of the cylinder. The failure in this region was also characterized by fiber splits, and bending of fiber ends.

Figure 2-75. SEM Photographs of Damage on Inner Surface of Cylinder
 (a) Low Magnification Showing Splitting
 (b) High Magnification Showing Splits and Bending of Fibers

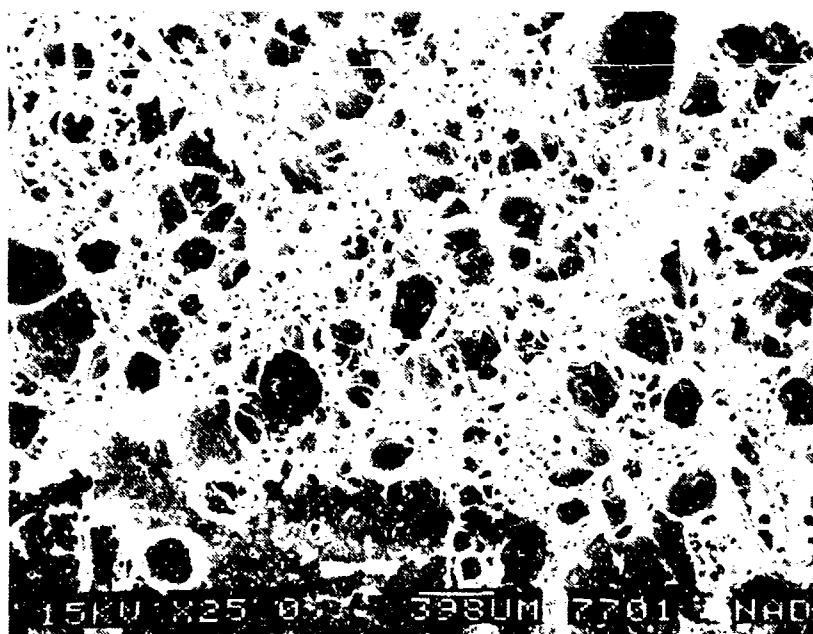
The top surface of the compound plate was also examined. The section was extremely brittle and delaminated upon gentle handling with a tweezer (Figure 2-82). Evaluation of the fragment, which appeared to be ceramic in nature, revealed evidence of overheating as suggested by the bent contour (Figure 2-83a) and voids observed during SEM examination (Figure 2-83b).

Figure 2-83. Optical and SEM Photographs of Delaminated Fragment of Top Surface of Compound Plate
 (a) Oblique View Showing Bent Contour of Fragment
 (b) Voids on Top Surface

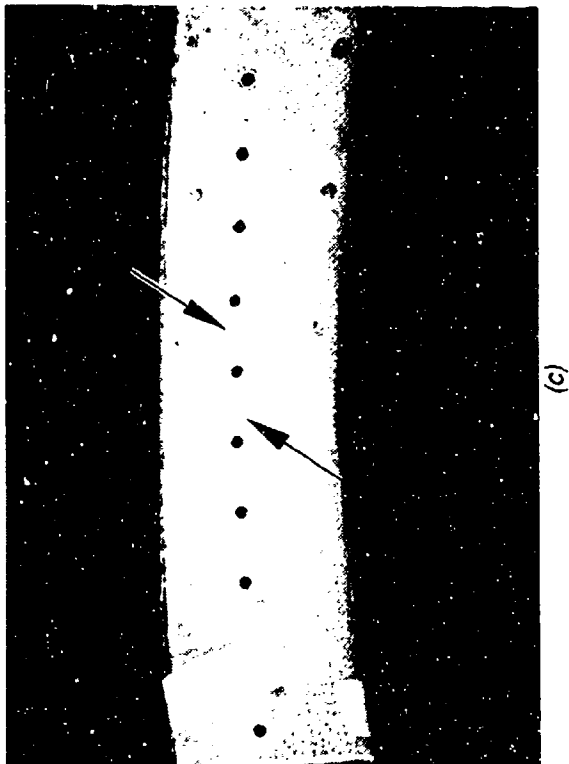
Figure 2-84 shows a collage of the part in the as-received condition. Close examination of the part indicated that the component consisted of a thin woven sheath (believed to be Kevlar/epoxy) enclosing a laminated bow (believed to be filament wound Kevlar/epoxy and glass/epoxy). The part was associated with extensive cracking all around the outer periphery (see Figure 2-84b); and along the inner diameter in mid-section regions containing fastener holes (see Figure 2-84c, and Figure 2-85a). When viewed obliquely, the sheath appeared torn in several areas (see Figure 2-85b). The entire sheath appeared loose and disbonded, and barely held in place by the ends. In addition the bow was associated with extensive delaminations (see Figure 2-85c), as determined by simple visual examination of the part.

Figure 2-84. As-Received Documentation of Composite Arch Reinforcement
 (a) Overall View
 (b) Cracking in Outer Periphery of Sheath (Arrow)
 (c) Cracks in Mid-Section Fastener Holes (Arrows)

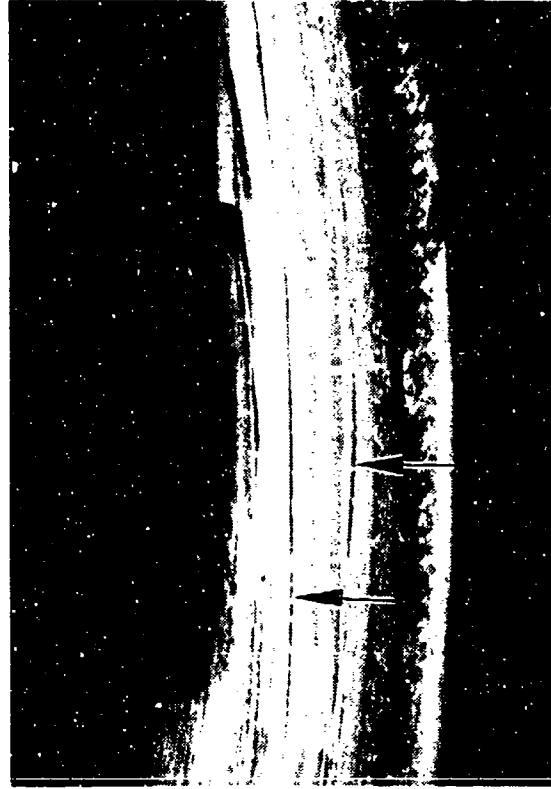
Figure 2-85. Documentation of Cracks in Part
 (a) Shear Cracks in Fastener Holes (Arrows)
 (b) Oblique View Showing Tearing of Sheath
 (c) Delaminations in Bow Contained by Sheath
 (Arrows)

Initial examination was concentrated on the cracks observed in the sheath and bow around fastener holes (refer to Figure 2-85a). The general appearance of these cracks suggested that these were shear cracks, rather than tensile cracks. Figure 2-87 presents fracture features observed in the sheath in the region of a fastener crack. The fracture was characterized by dense tangles of fibrils (Figure 2-87b), as would be expected in translaminar failures in Kevlar/Epoxy. Examination of the regions below the fibrils revealed a delaminated surface associated with hackles, as is shown in Figure 2-87c, indicating that the fastener cracks were shear cracks. The orientation and morphology of the fibrils suggested that cracking in this region occurred under in-plane shear loads, resulting in tensile failures of the Kevlar fibers. Figure 2-88 presents a delaminated region in the bow in the vicinity of a crack. The fracture was once again characterized by shear failure characteristics, namely the occurrence of hackles in the resin (Figure 2-88a). The glass fibers, and Kevlar fibrils (Figure 2-88b) were characterized by tensile fracture characteristics.

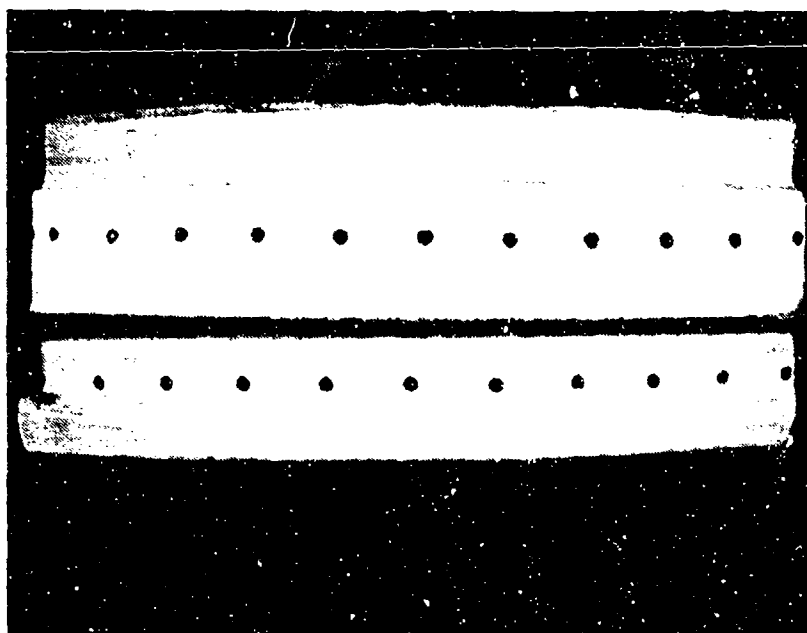
Figure 2-86. Documentation of Ply Removal and Sectioning
(a) Sectioning of Part

arbitrarily labeled as A, B, C, and D in Figure 2-86a. Upon sectioning, the sheath totally separated from the bow in the sections labeled B, and C. In addition the bow delaminated into two fragments in the section labeled C, as is illustrated in Figure 2-86b.

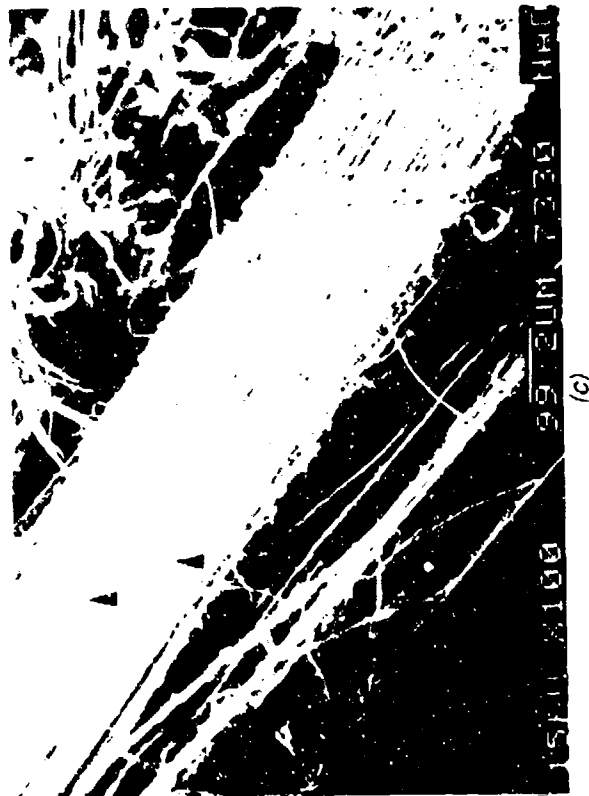
Elementary stress computations indicated that the delaminations in the sheath and bow were caused by the part being subjected to bending and torsional loads. The occurrence of shear cracks in mid-region fastener holes suggests that one or more of the fasteners may have been loose in these regions introducing localized bending and buffeting. Shear cracks formed in these regions, and with the resultant change in loading, the sheath and bow delaminated. The sheath was very poorly bonded to the bow and the bow exhibited severe porosity. It is believed that these material defects resulted in enhanced delamination of the bow.

Figure 2-87. Optical and SEM Photographs of Shear Fracture at Fastener Hole
 (a) Macro photograph of Crack
 (b) SEM Photograph Showing Kevlar Fibrils in Crack Viewed End On
 (c) Delamination Surface Containing Hackles (Arrows)

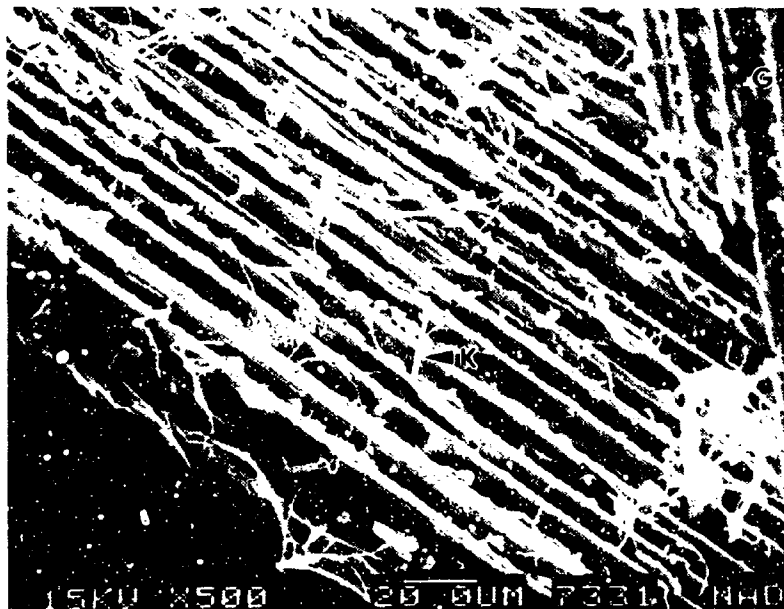
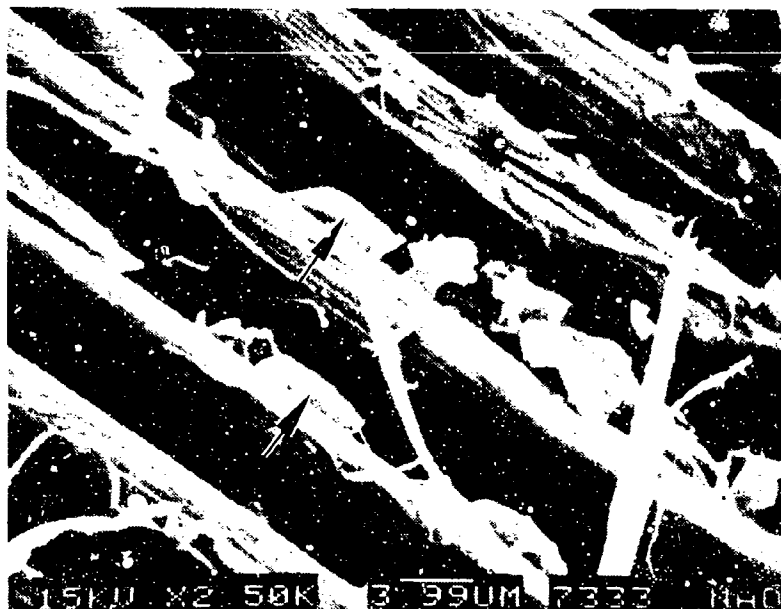
Figure 2-88. SEM Characterization of Fastener Hole Crack in Bow
 (a) Glass (G) and Kevlar Fibrils (K)
 (b) Hackles in Resin (Arrows)

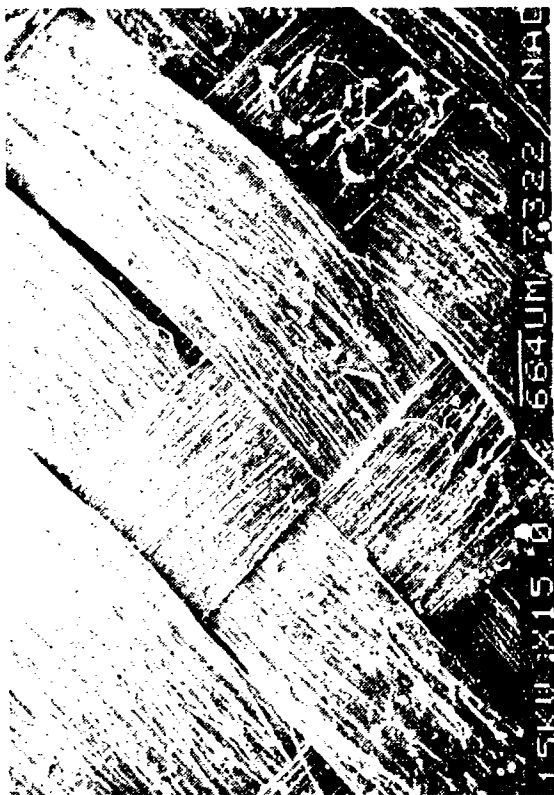
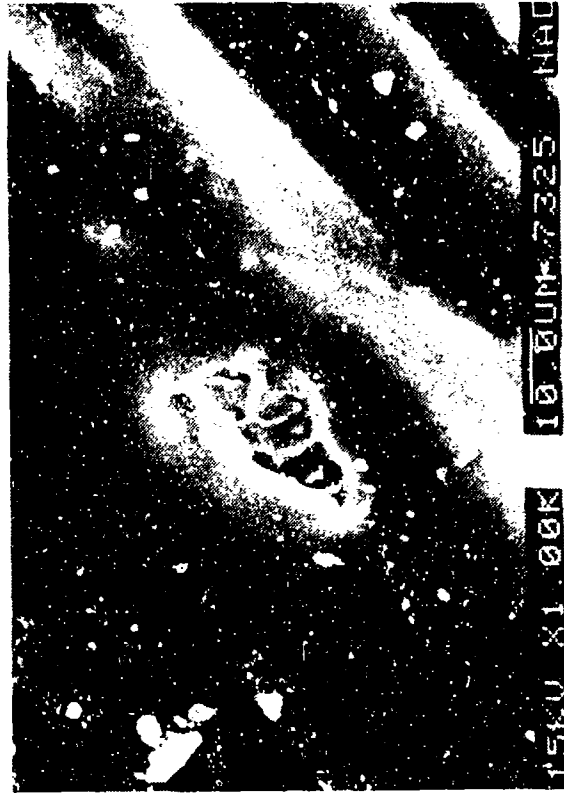
Figure 2-89 shows features observed on the bottom surface of the sheath that had separated from the bow. As can be seen in Figures 2-89b and 2-89c, there was practically no evidence of bonding of the sheath to the bow. Figure 2-90 shows optical and SEM photographs of the mating surface where the sheath should have been bonded. Again there was practically no evidence of fracture, with the surface appearing to be in the original unbonded state, and with occurrence of porosity.

Figure 2-89. Characterization of Sheath Surface
 (a) Macro photograph Showing Separation From Bow
 (b) Macro photograph of Sheath Surface
 (c) Absence of Bonding With Bow

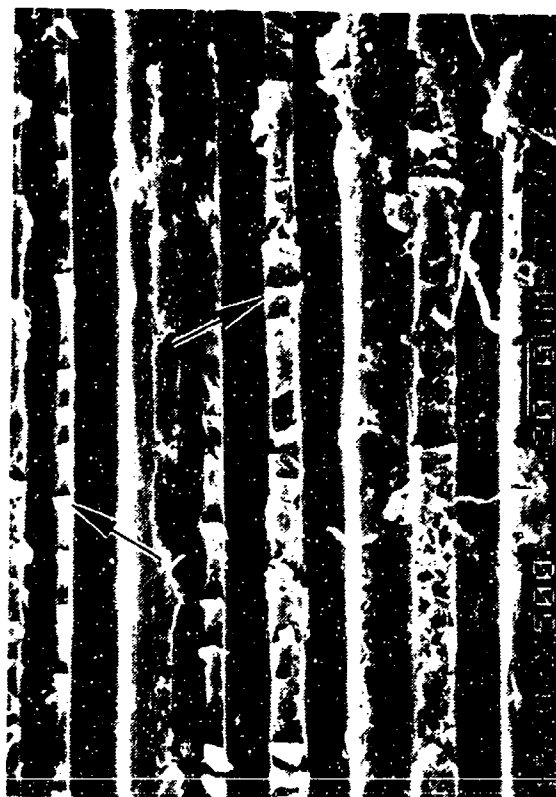
SEM examination was also carried out on the delaminations in the bow (refer to Figure 2-86b). Figure 2-91 presents optical and SEM fractographs of fracture features observed in a principal delamination in the bow mid-section. Fracture was characterized by in-plane shear failure characteristics, namely translaminar tensile fracture in the glass and Kevlar fibers (Figure 2-91b), and hackles in the fractured resin (Figure 2-91c).

Figure 2-91. SEM Characterization of Bow Delamination
(a), (b) Tensile Failure of Kevlar and Glass Fibers
(c) Hackles (Arrows) in Resin
